# 4-Point Inspection Form

ID# 1939360Insured/Applicant Name: John Cabrera Application / Policy #: \_\_\_\_\_Address Inspected: 9909 Earlston St Orlando, FL 32817Actual Year Built: 1985Date Inspected: 1/14/2026**Minimum Photo Requirements:**

# 4-Point Insurance Inspection Photos

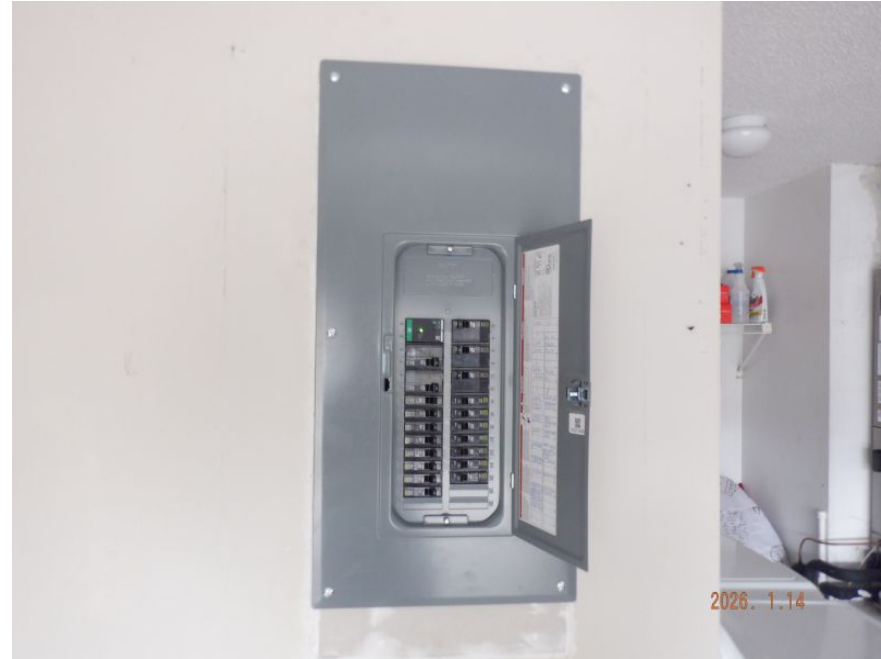
Interior Panel

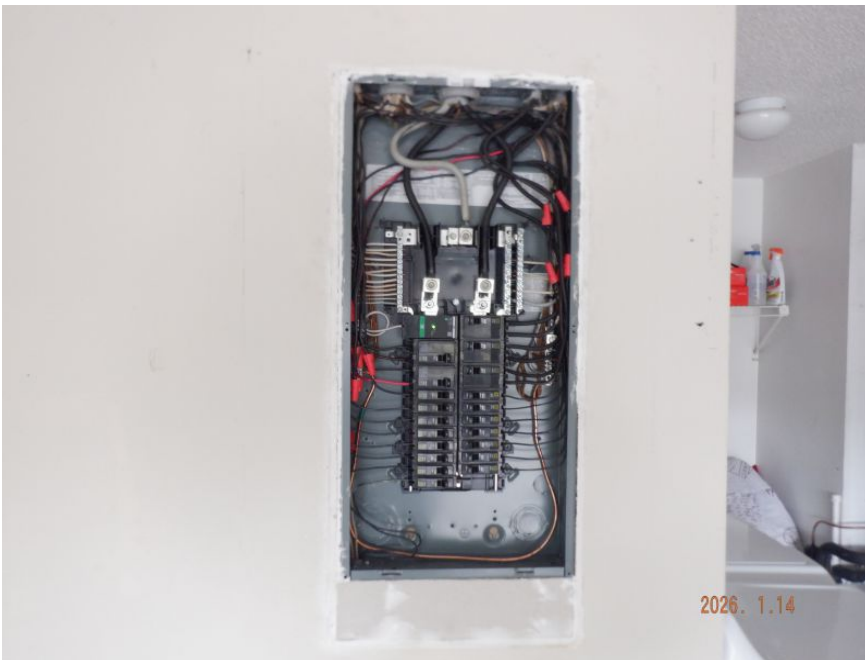
Interior Panel Wiring

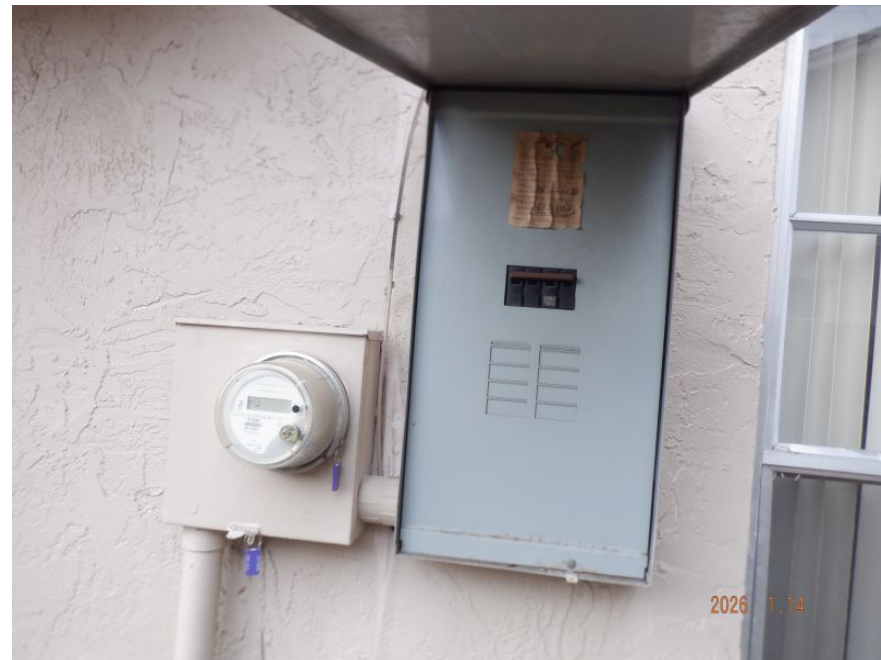
Exterior Panel/Meter

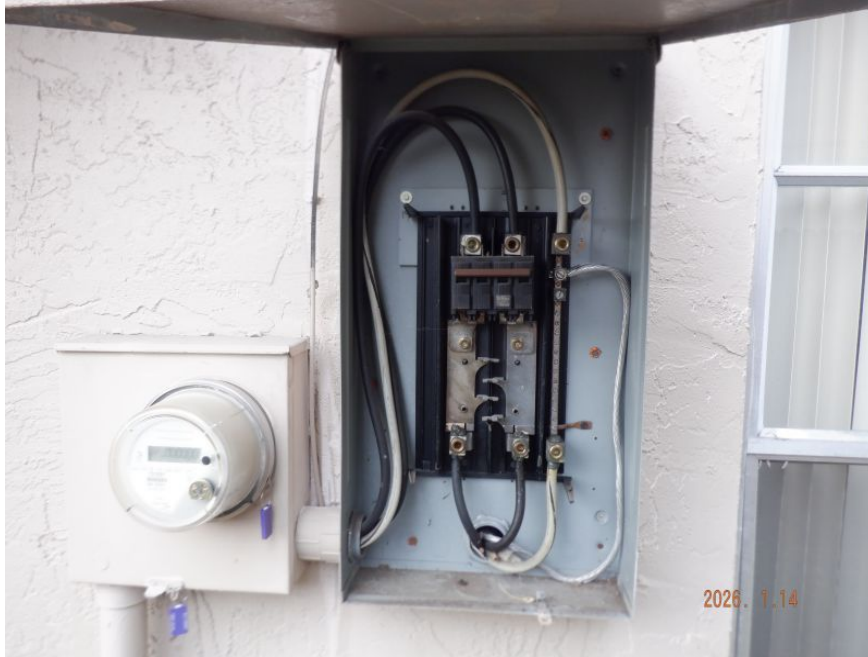
Exterior Panel Wiring

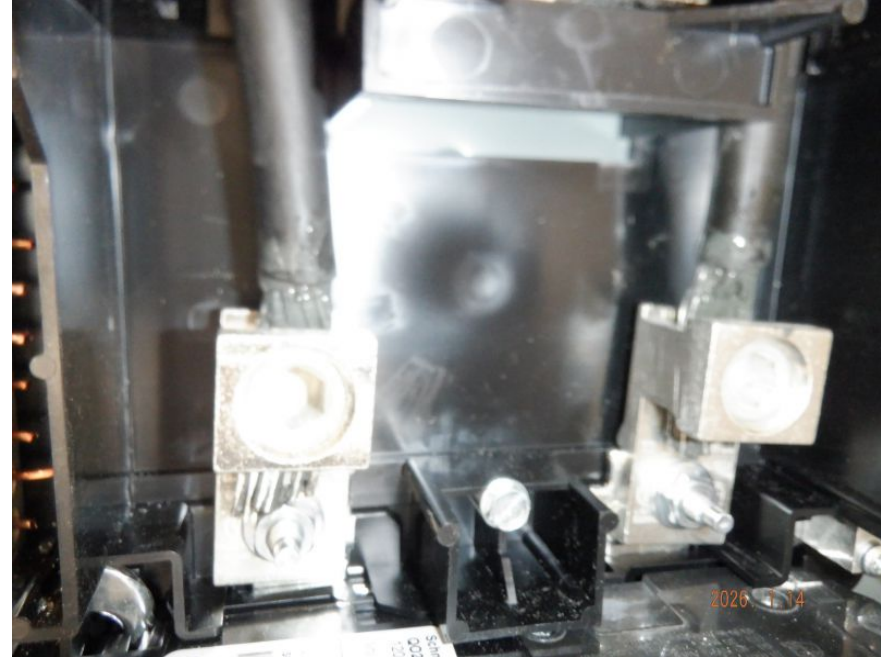
Electrical System: All aluminum wiring found is multi-strand, location: Main Feed & Between Panels.

Aluminum Wiring

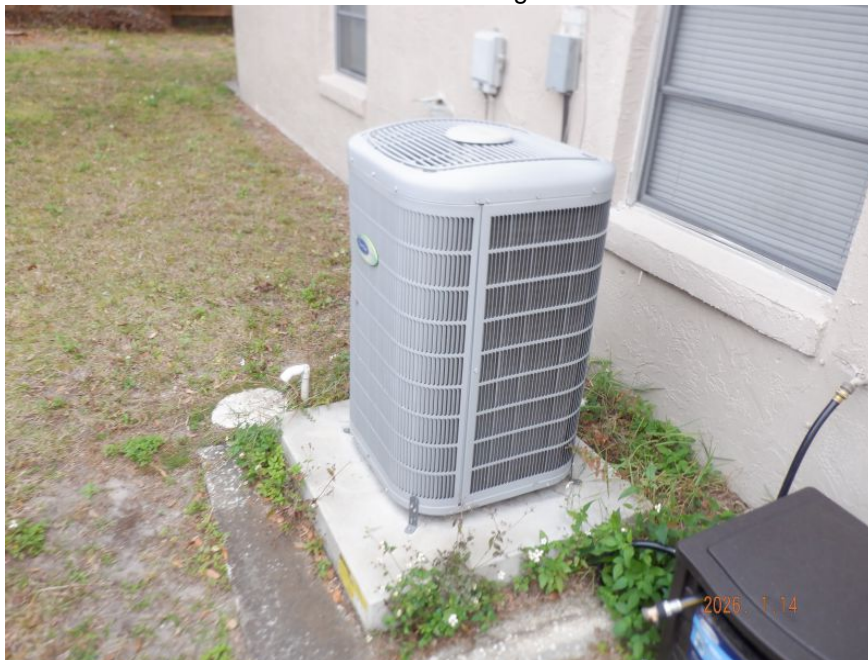
Ac Unit 1

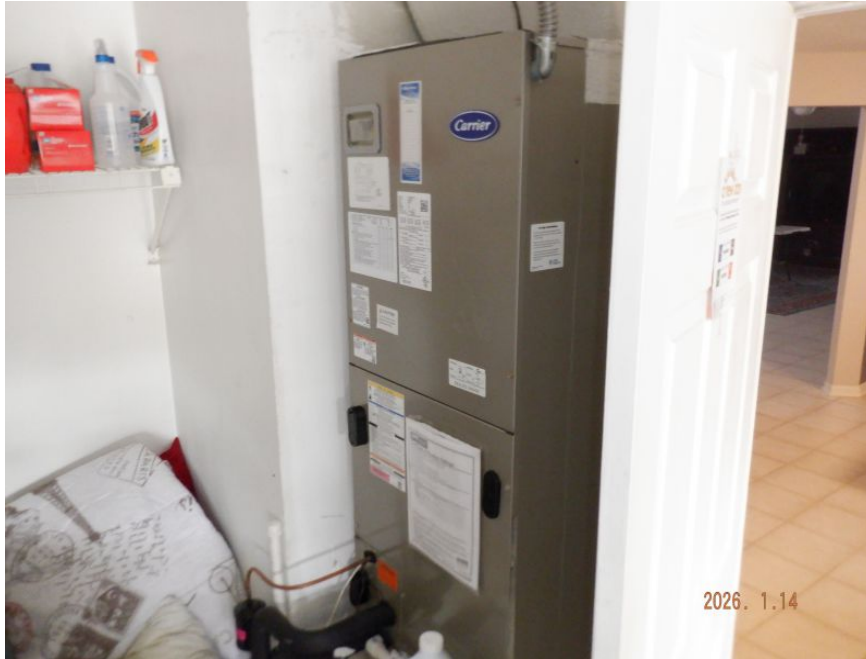
Air Handler

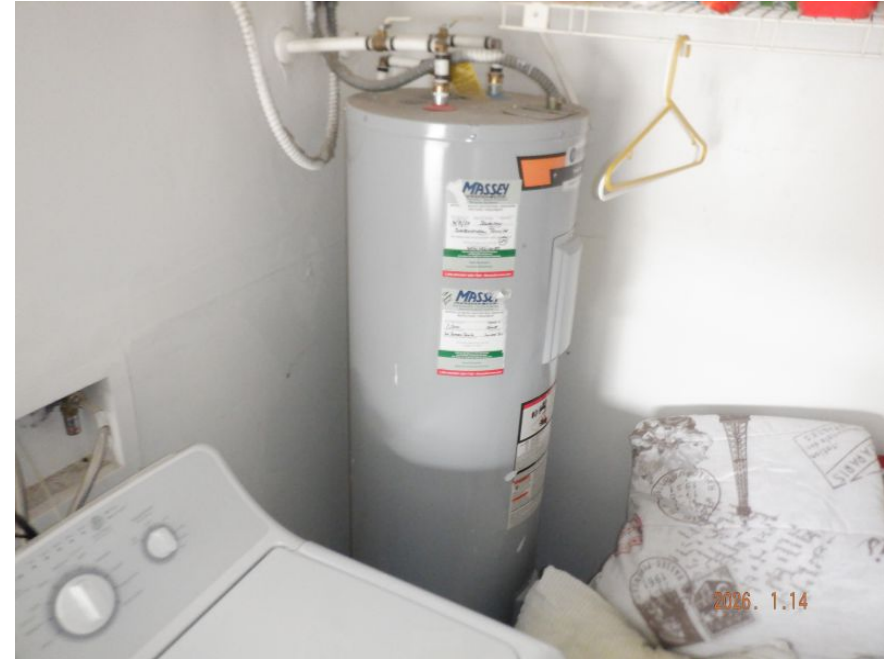
Water Heater

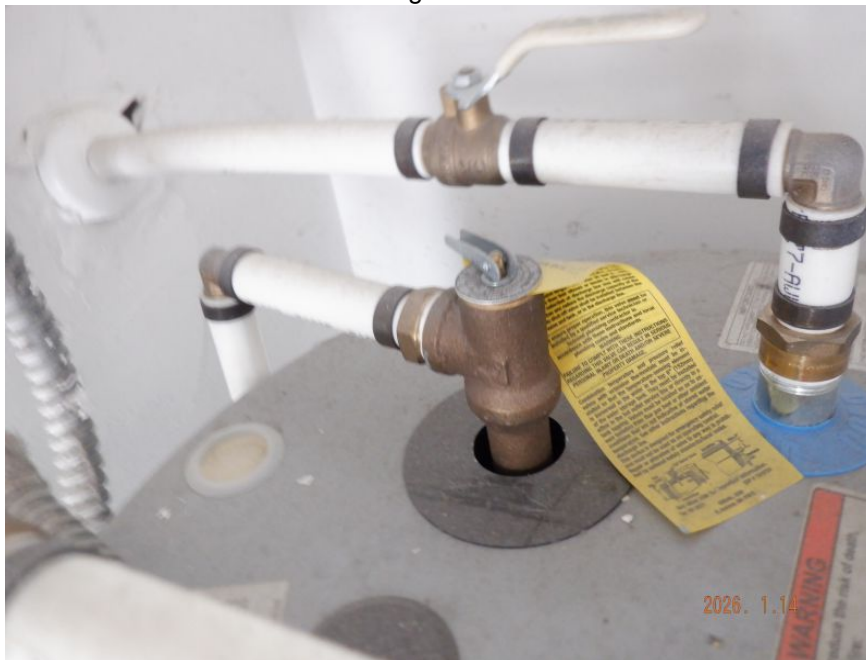
Water Heater Pressure Valve

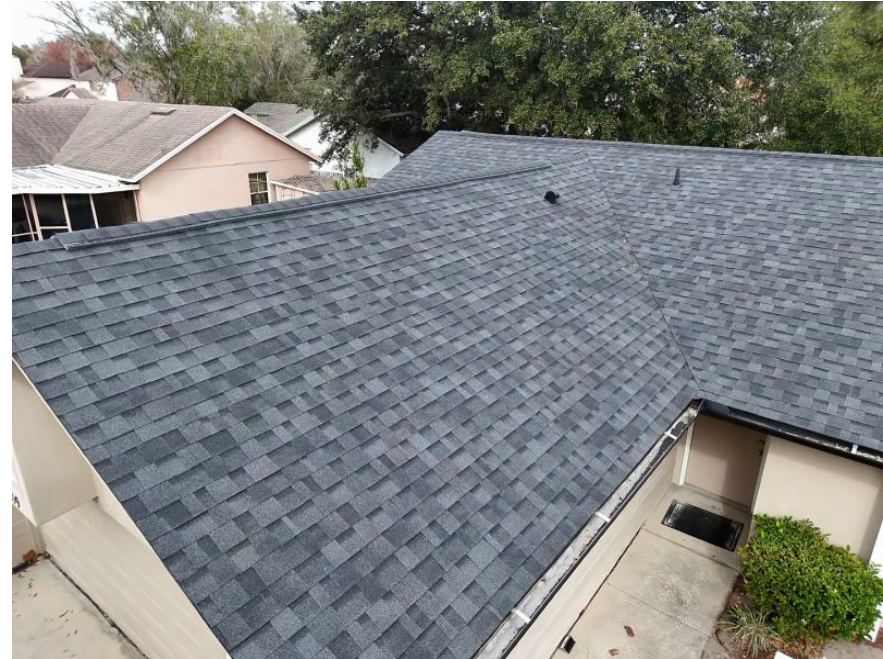
Architectural/Dimensional Shingle Roof Covering

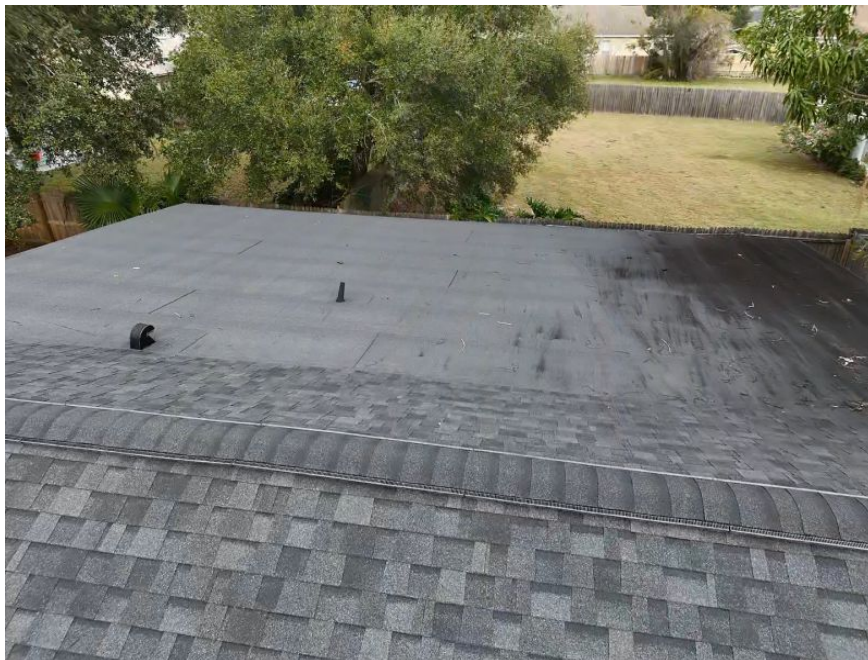
Built-Up/Rolled Asphalt (Sloped) Roof Covering
