Inspection
1939360

Windstorm Mitigation Inspection

John Cabrera
9909 Earliston St
Orlando, FL 32817
January 14, 2026

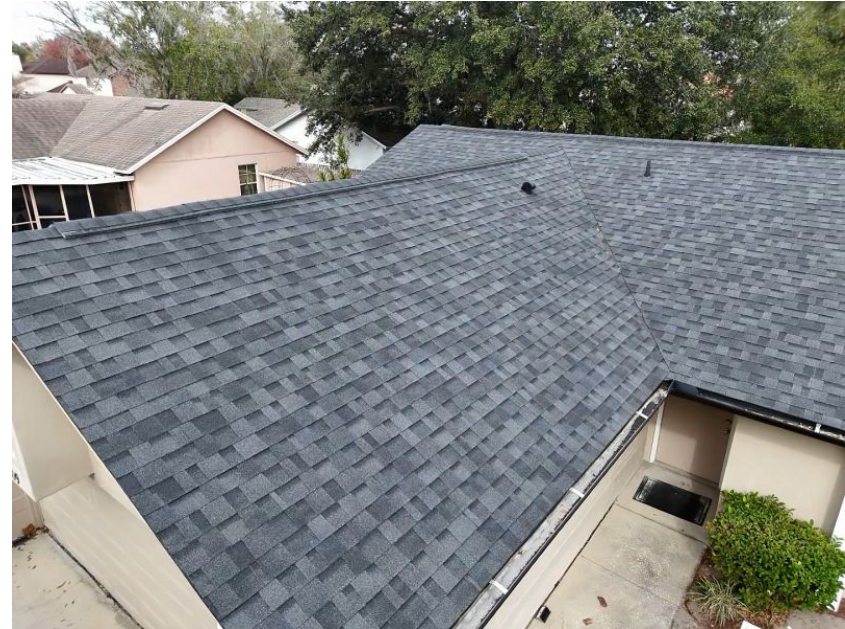
Architectural/Dimensional Shingle Roof Covering

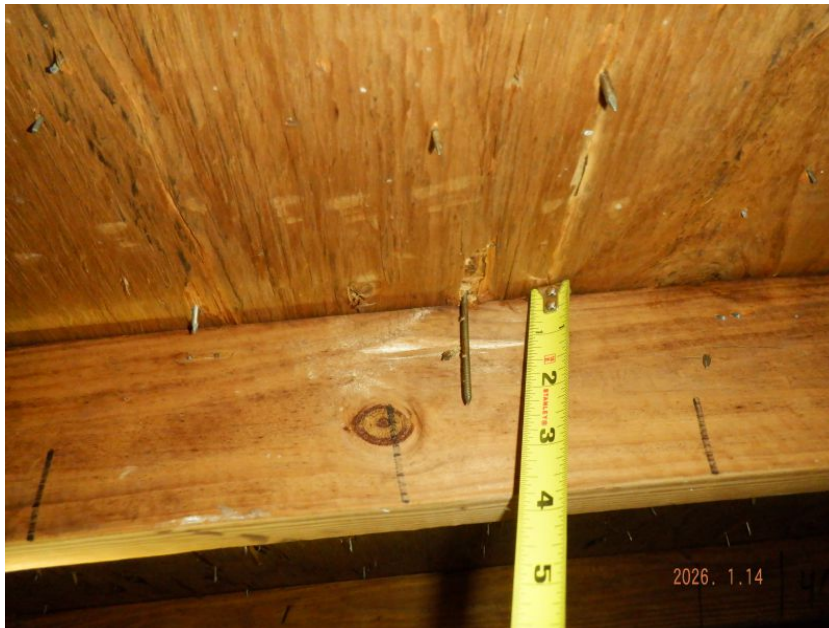
8d Nails or Greater in Size

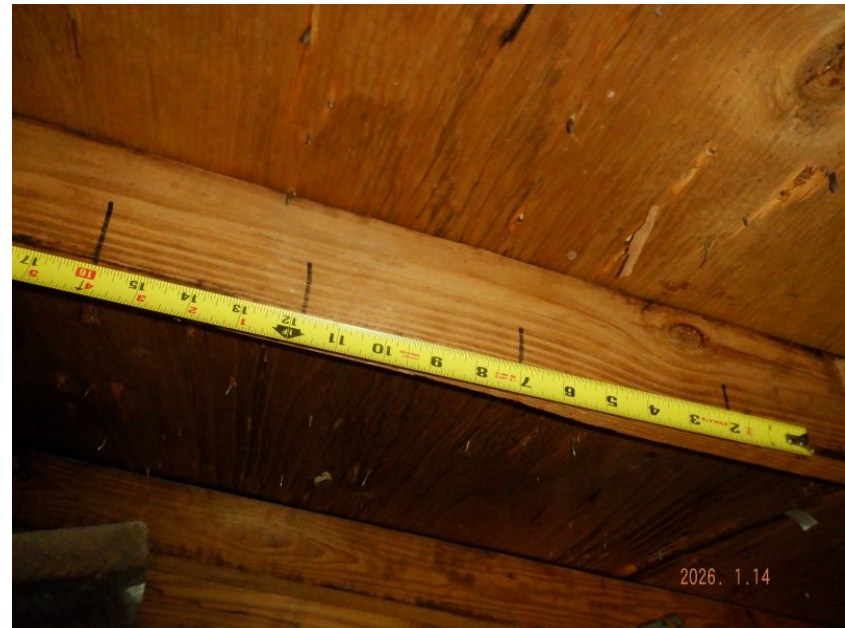
8d Nails or Greater in Size Spaced 6" Along the Edge

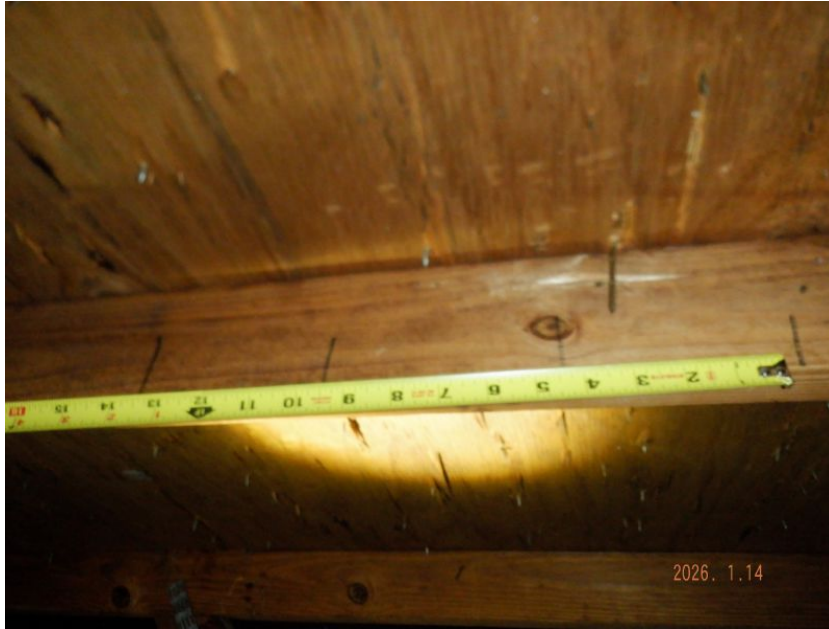
8d Nails or Greater in Size Spaced 6" in the Field

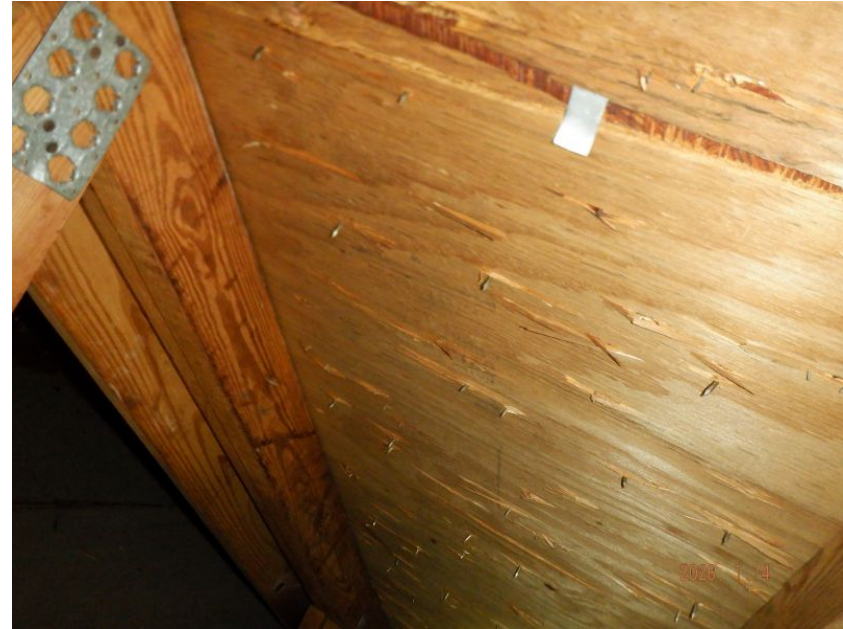
7/16" Deck Thickness Confirmed

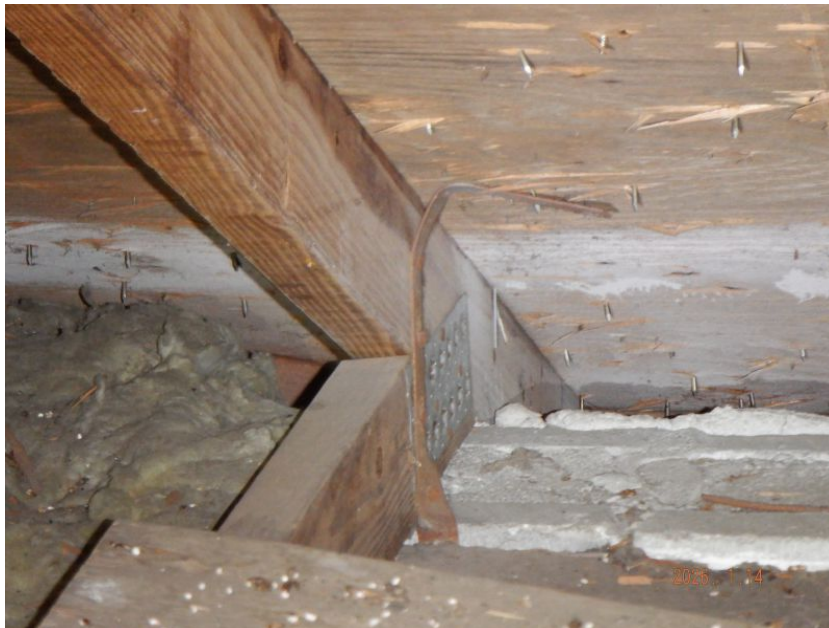
Metal Connector with 3 Nails

Roof-to-Wall Attachment. Our report indicates that the existing roof-to-wall attachment(s) do not meet the requirements on the Uniform Mitigation Verification Inspection form for Single Wrap Straps. This definition requires at least two nails on the front side and at least one on the other of every strap in the attic, on every truss or rafter. As it is often difficult to access every truss or rafter, the ideal time to upgrade this feature is when the roof deck is being replaced. In some circumstances, this work can be done on its own; consult a professional for details. Retrofits to existing roof to wall connections should be permitted with the local building department, and installations should follow the manufacturer's guidelines.

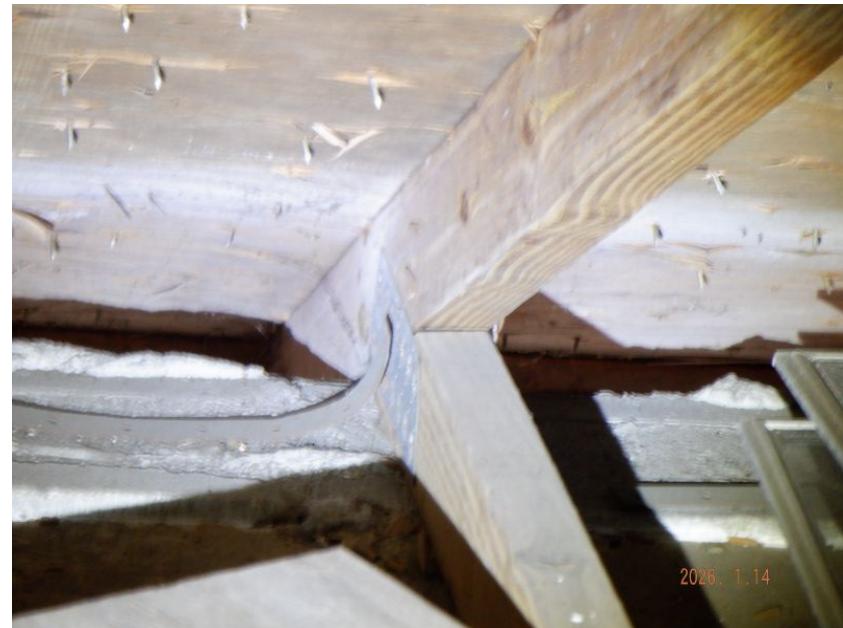
Opposing side of Truss

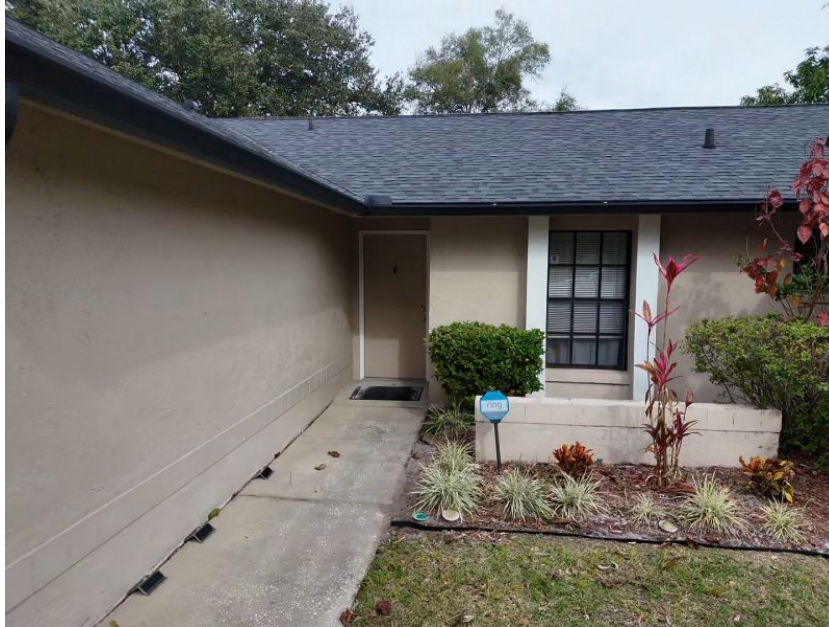
Unprotected Window

- Front Elevation: 2 windows**
- Back Elevation: 1 entry door, and 4 windows**
- Left Elevation: 2 windows**
- Right Elevation: 3 windows**

In order to obtain a valid A-A.3 rating, the following opening(s) would need to be protected or replaced using a qualifying impact-rated ("A") device:

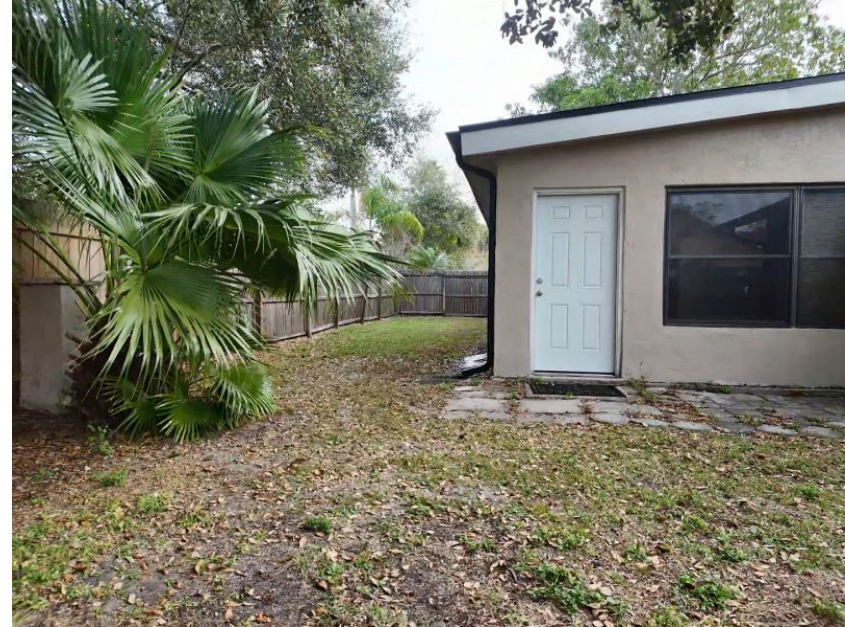
Unprotected Solid Entry Door

- Front Elevation: 1 entry door, and 1 garage door**
- Back Elevation: 1 entry door**

In order to obtain a valid A-A.2 rating, the following opening(s) would also need to be protected or replaced using a qualifying impact-rated ("A") OR pressure-rated ("D") device:
